**SITE ASSESSMENT REPORT
FOR
FORMER ELECTROFINISHERS
CHICAGO, COOK COUNTY, ILLINOIS
TDD: 312-0006-017
PAN: 0N1701SIXX**

October 25, 2000

**UNITED STATES ENVIRONMENTAL PROTECTION AGENCY
77 West Jackson Boulevard
Chicago, Illinois 60604**

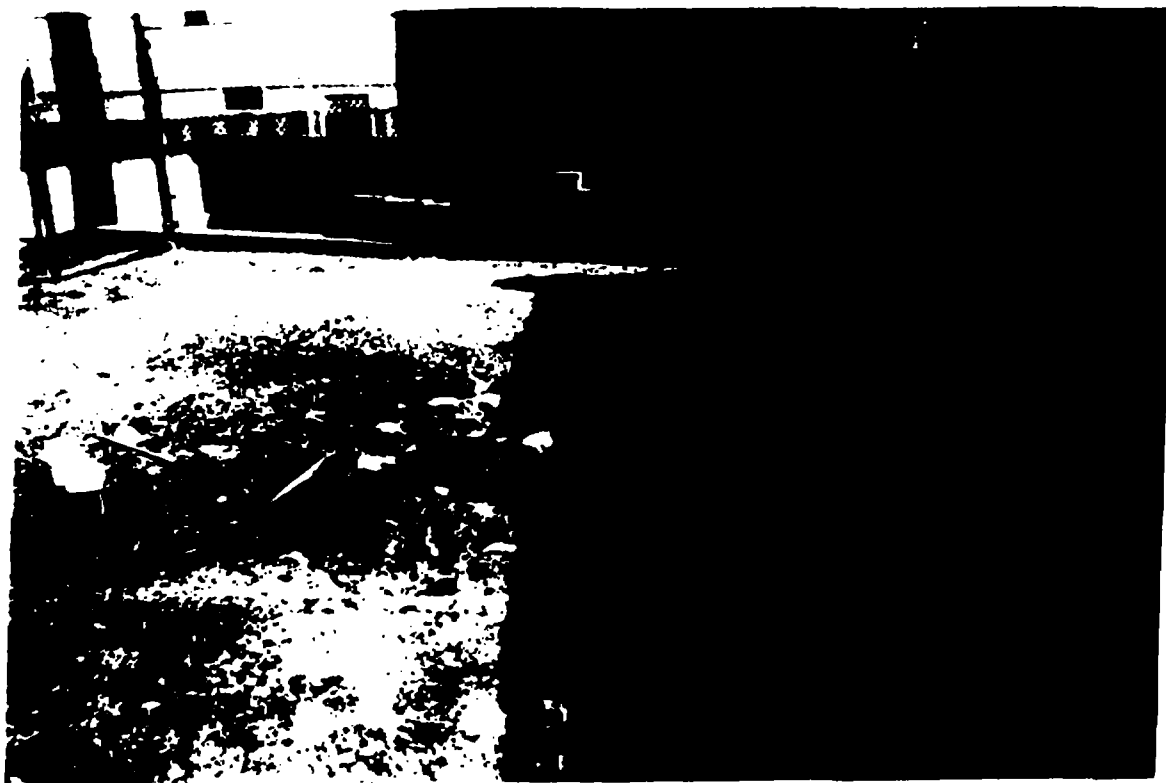
| Sample Number | Time of Collection | Matrix | Location |
|---|---|---|--|
| ES-2 | 1010 | soil | Soil debris pile in northwest yard |

Site: Former Electrofinishing
 TDD: S05-0006-017
 Date: 8/10/00 Time: 1010 Direction: N
 Photographer: J. Eueck
 Description: Soil sample location 1 S2, debris pile in northwest yard

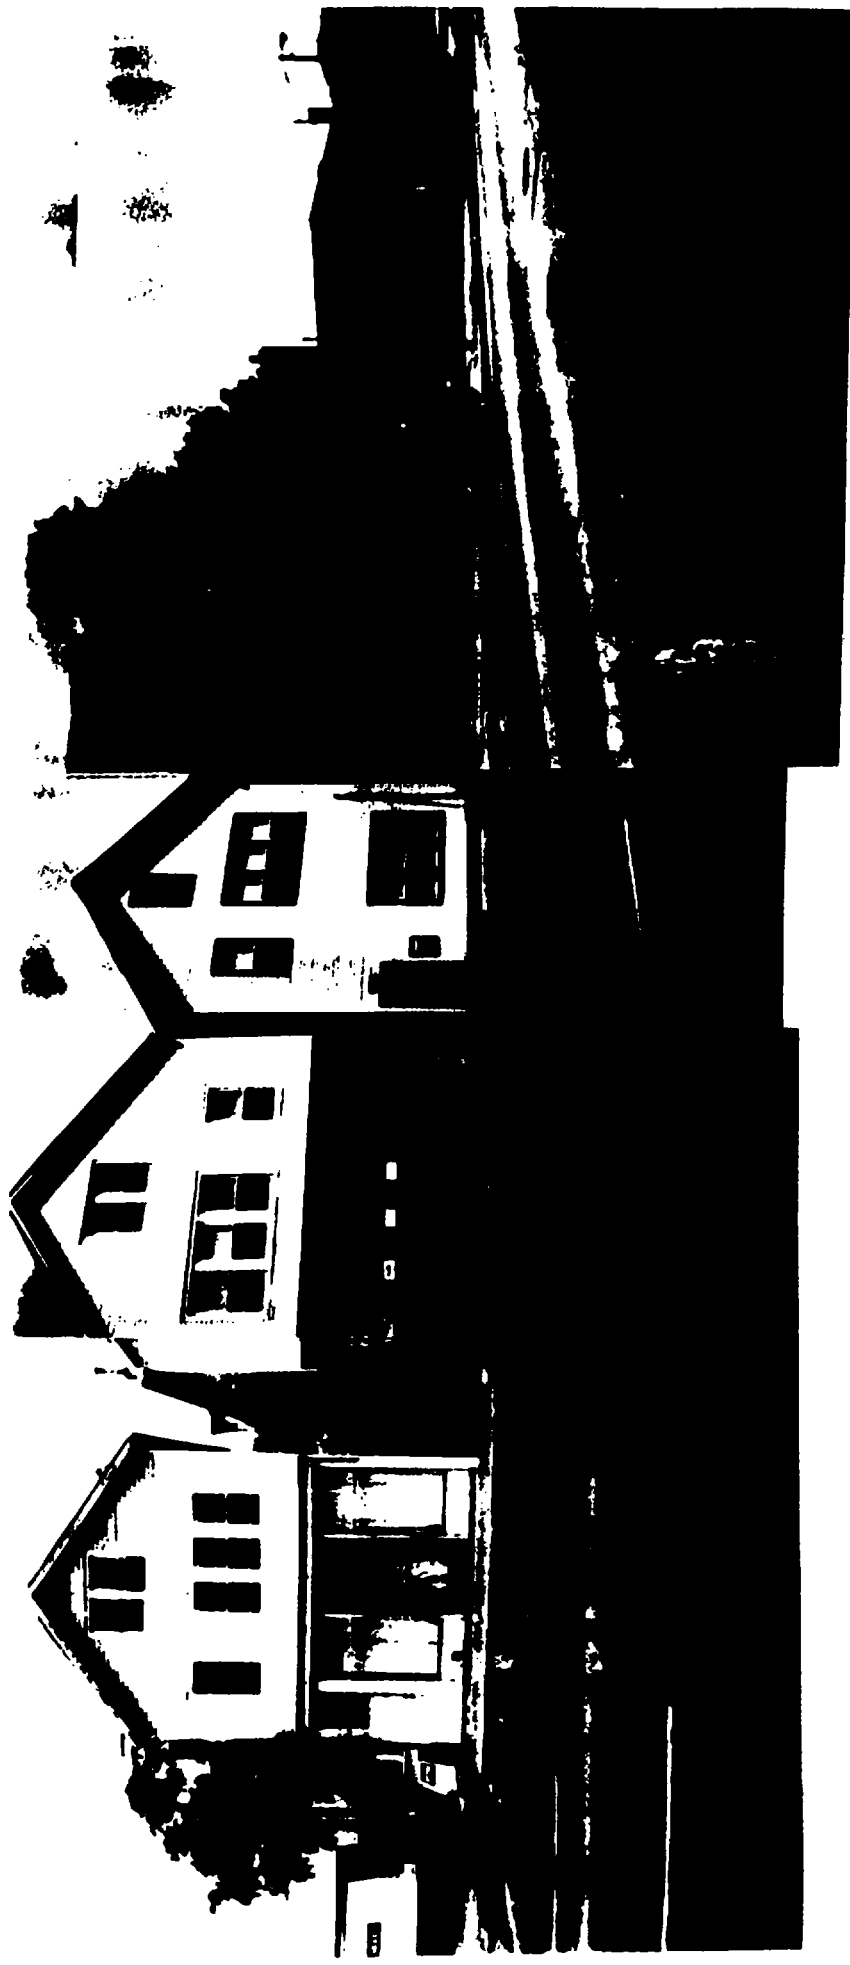
Description: Panorama of three residential buildings (left) and three joined brick site buildings (right)

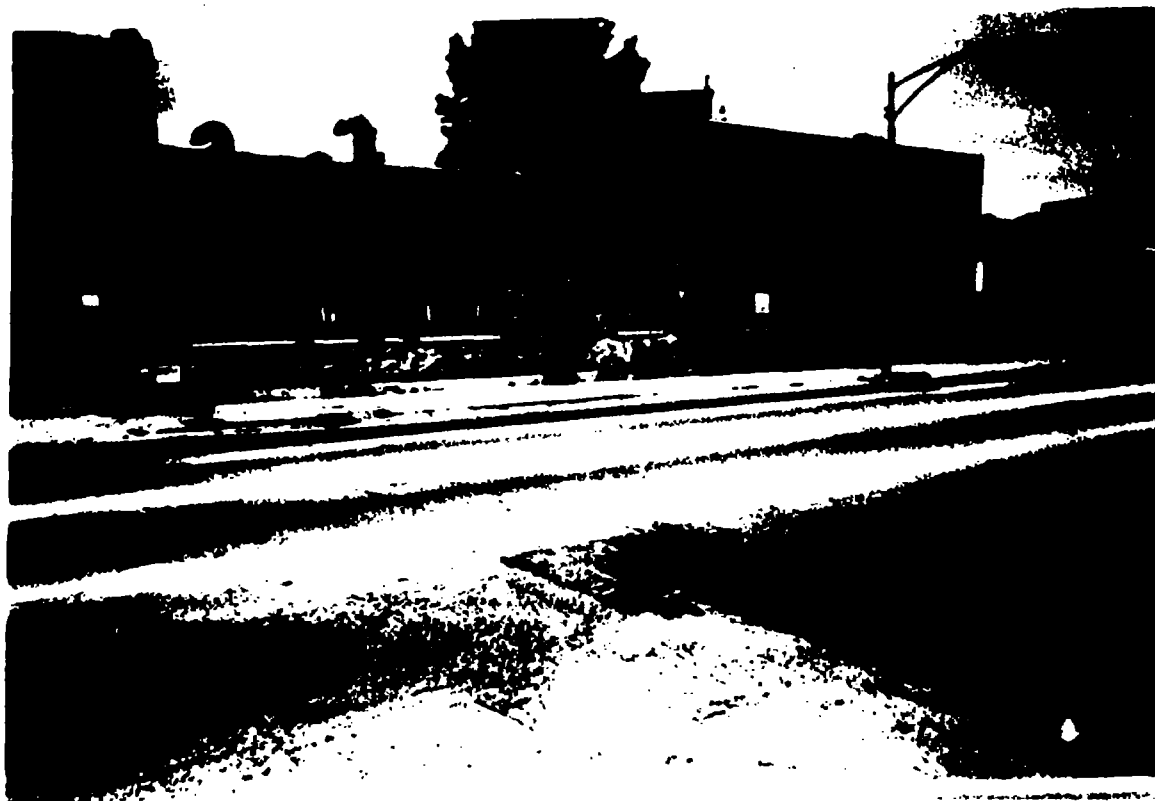
Description: Building A (left), Building B (middle), Building C (right), dark brick building with overhead door at far right is Building D
